ISSUE NO. : 10-006	DATE : 15th Mar. 2010	PAGES : 1 OF 1
--------------------	-----------------------	----------------

SUBJECT	Modification of Engine Earth Lead Wire
MODEL	GT650, ST7
EFFECTIVE F/M NO

This service bulletin is written to announce a modification of Engine Earth Lead Wire

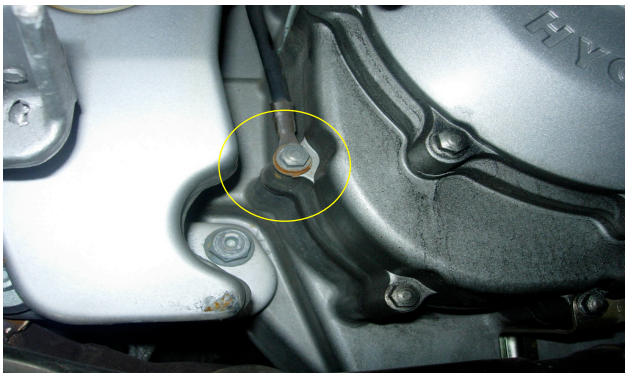
- 1) Engine earth of wiring harness is connected to assembly bolt of painted Clutch cover.
The painted clutch cover makes high resistance and sometimes wiring harness is melted by high resistance.

<BEFORE : CLUTCH COVER - M6 BOLT >

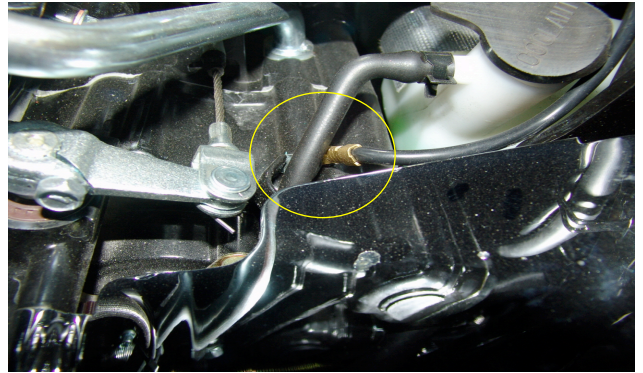
<AFTER : CRANK CASE, LH - M6 BOLT >

- 1) The connection point of harness has been changed.
- 2) We put masking tape round the bolt connection point while painting the crank case.
